Summary of Color Difference on Exterior of Stainless Steel Buildings

China Construction Shenzhen Decoration Co., Ltd, Shenzhen, China

China Architecture Science and Technology Museum of China Construction • Start of Optics Valley is located at the northeast corner of intersection of Gaoxin Avenue and Guanggu 6th Road in Wuhan (hereafter referred to as “Science and Technology Museum”).

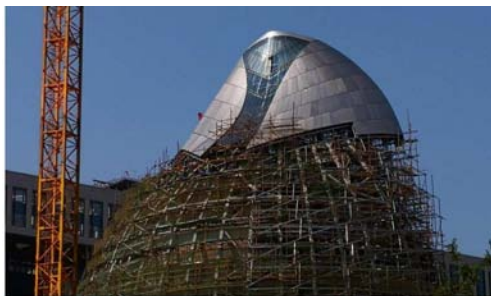
After the installation of the top stainless steel plates of the Science and Technology Museum, color difference between the top stainless steel plates installed around the building was found in the distance. The color changed with different viewing angle. The color difference was also different when observed in the morning and evening, or on sunny, cloudy and rainy days.

Figure 3. Stainless steel color difference (illuminated face).

The on-site installation was suspended immediately; the plate production in processing plant was stopped [1].

The plates sent from the factory to the site have undergone strict quality tests before delivery, including hyperbolic deformation accuracy, comparison of plate appearance with sealed samples, and a series of inspections in product processing [2]. After the occurrence of color difference, the company established a color difference team, sent representatives to inspect plates on site, and went to the processing plant to check the processing of stainless steel panel immediately.

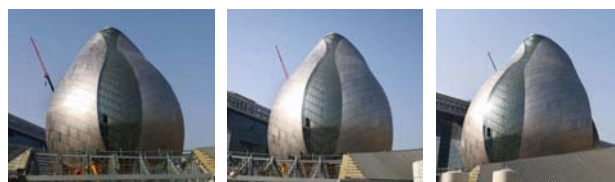
Buildings will have reflected color difference depending on the angle of sunlight. The different light reception degrees are mainly caused by three factors: light angle, viewing angle of human body and plate roughness.

Figure 9. Outside of large leaf with different shooting angles.

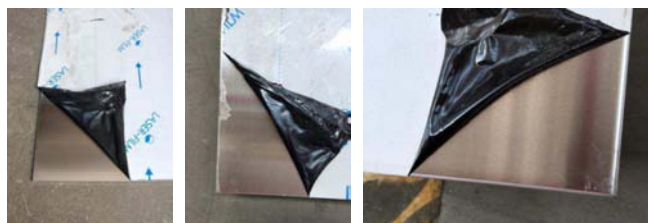
(1) The raw material plates of three furnace numbers were marked with Furnace A, Furnace B, Furnace C and grain direction of plates respectively, and cut into six pieces of 1000mm×1000mm by laser. The surface films were torn apart to compare whether the raw plates have color difference.

Figure 10. Raw plates of three furnace numbers.

(2) Six plates of different furnace numbers (2 plates for each furnace number) were sandblasted in the direction marked on the sandblasting machine (old machine). According to actual observation, there is no color difference between plates with different furnace numbers using the same sandblasting machine.

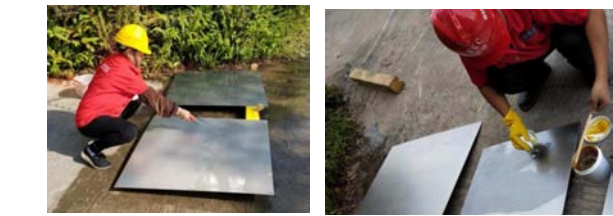
Conclusion of Test 2: The raw material plate with furnace number of Furnace C was marked with grain direction of plate and cut into four pieces of 1000mm×1000mm by laser. Polishing was carried out first. Two pieces of plate were sandblasted in the direction marked on the newly purchased small sandblasting machine (new machine); the other two were sandblasted in the direction marked on the original large sandblasting machine (old machine). According to the observation of samples, it was found that the sandblasting of small sandblasting machine (new machine) is relatively rare with sandblasting lines. The sandblasting color of large sandblasting machine (old machine) is darker. A piece of plate sandblasted by the small sandblasting machine (new machine) and a piece of plate sandblasted by the large sandblasting machine (old machine) were taken for pickling [9].

Figure 11. Pickling on outer surface of stainless steel.

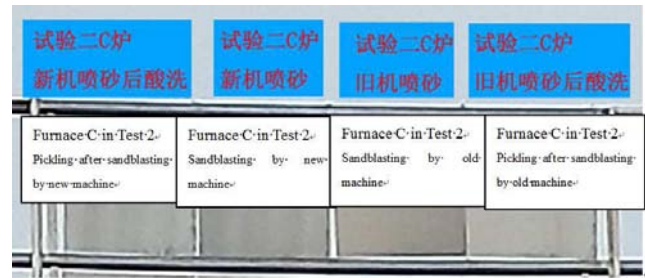
Figure 12. Comparison after pickling.

Discoveries in the test: The acid concentration, acid's duration of stay on the stainless steel surface and the sun's temperature obtained on the stainless steel surface will change the color difference after pickling significantly. The color of stainless steel surface will be inconsistent under slightly different pickling conditions.

According to the test, pickling on stainless steel surface should be eliminated first. There will be obvious color difference between the surface colors of plates after pickling. The uniform color of stainless steel surface of entire building can only be achieved by immersive pickling, but it cannot be implemented. If large-area pickling is carried out in situ, there is a hidden danger of liquid flow marks, which will cause secondary color difference.

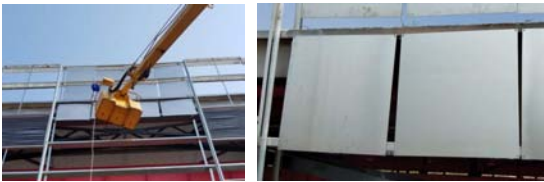
Figure 13. Effect of fluorocarbon spraying on outer surface of stainless steel in high-altitude simulation.

The surface texture can be obviously covered by contrastive paint spraying at close range. According to the observation from a distance, the plate had even color and reflection, without specific metallic luster of stainless steel.

After the stainless steel is sprayed on the ground, the color and film adhesion testing are controllable. However, the high-altitude spraying may not be controlled accurately due to high altitude environment, wind effect, distance of spraying and manual operation. The uniformity of spraying amount per unit area may also cause secondary color difference.

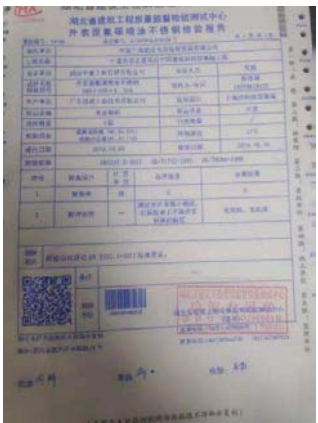
Figure 14. Test report.

Conclusion: In the surface coating testing, the adhesion is 0 without peeling.

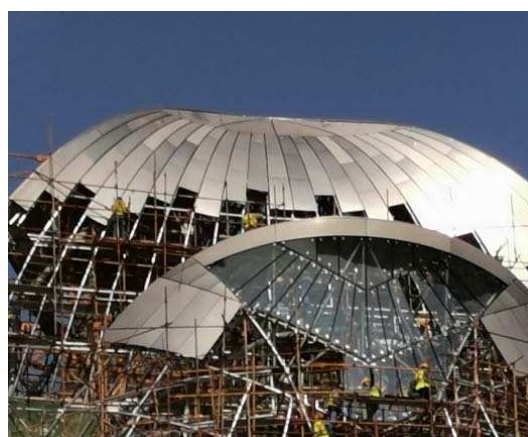
The installation of stainless steel took four months. In field observation, it was felt that as time went by, the overall outer surface color of stainless steel was more consistent with reduced color difference compared with the previous period [12].

Figure 17. Photo taken on a sunny day on August 29.

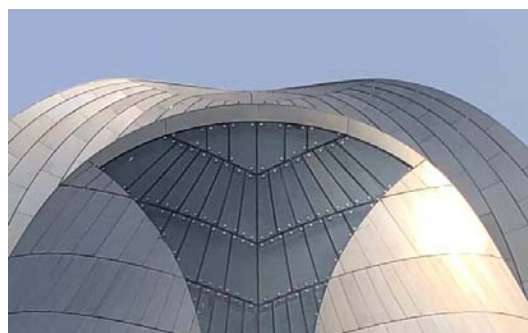
Figure 18. Photo taken on a sunny day on December 22.

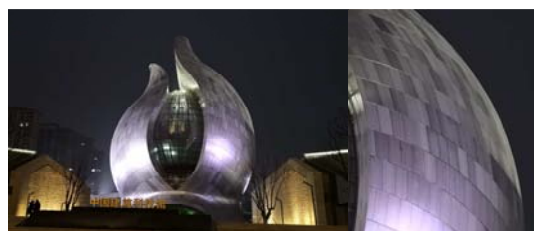
At night, lights around podium building irradiated the outer surface of stainless steel building with white bright cold light, the stainless steel surface showed obvious color difference.

Figure 19. Stainless steel color difference under cold light at night.

It is recommended to replace bright white lights around podium building with spotlights of different colors to irradiate the building exterior to form reflection on stainless steel surface. The building exterior will form a colorful visual effect with dynamic light irradiation, which will be an extraordinary visual appreciation [13].

It is recommended to replace the fixed light irradiation at night with dynamic dazzling lights to improve the technological appearance effect of building under lights and avoid the color difference under cold lights at night skillfully [15].

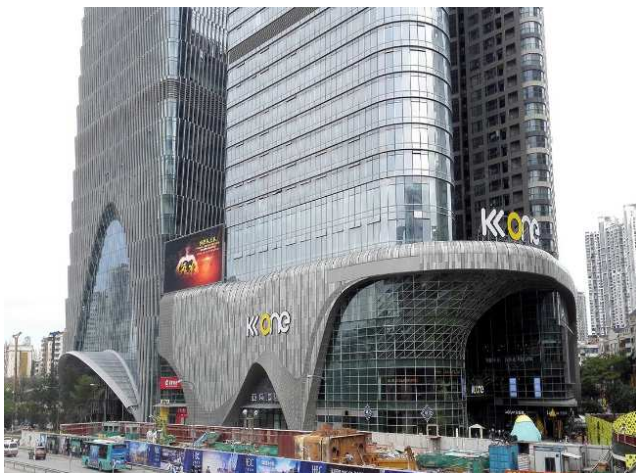
Figure 23. Stainless steel color difference of kkone Shopping Plaza in Shenzhen Binhe Shidai (daytime).

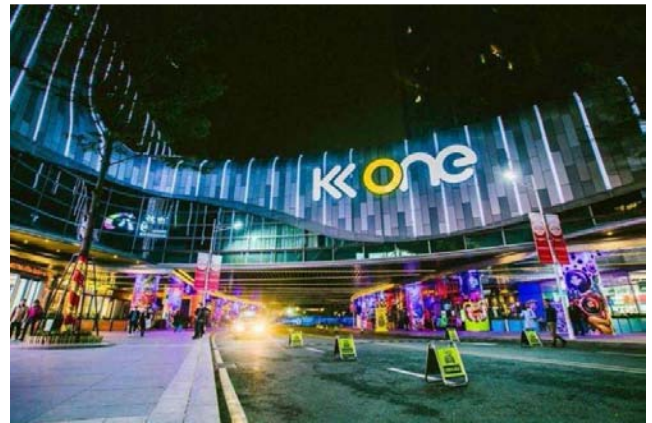
Figure 24. Stainless steel color difference of kkone Shopping Plaza in Shenzhen Binhe Shidai (light effect at night).

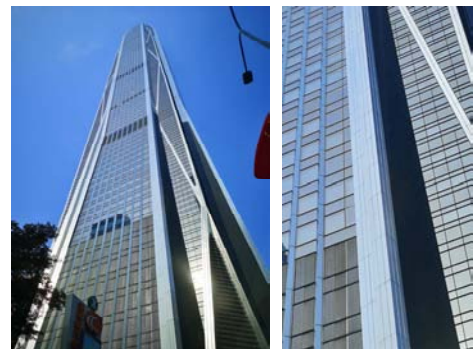
The stainless steel panels were completely cleaned with passivation cleaner. After the six months of natural passivation, the overall color tended to 95% consistency.

Figure 26. Stainless steel facade of Shenzhen Ping An Centre (effect of six months of natural passivation after cleaning).

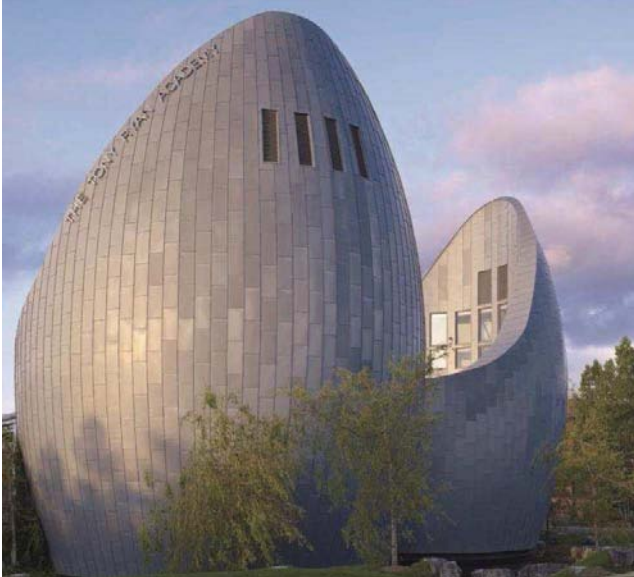
Figure 27. Color difference on stainless steel building exterior of Tony Ryan College in Dublin, Ireland.

The obvious contrast between bright and dark colors of stainless steel on shady face can be seen from the picture. The visual color difference is lighter on illuminated face, with no obvious color difference on convex curved parts. Some plates in concave parts have obvious color difference [14].

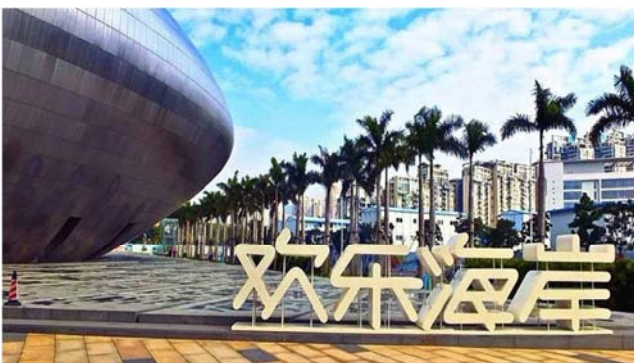
Figure 28. Color difference on stainless steel building exterior of Shenzhen OCT Harbour.

The stainless steel surface of Shenzhen OCT Harbour in above picture has similar color difference.
